Nanoparticles for stabilization of salts in St. Nicholas Church, Pittsburgh, Pennsylvania

Smith, M.¹ and Foulke, R*.²

ABSTRACT

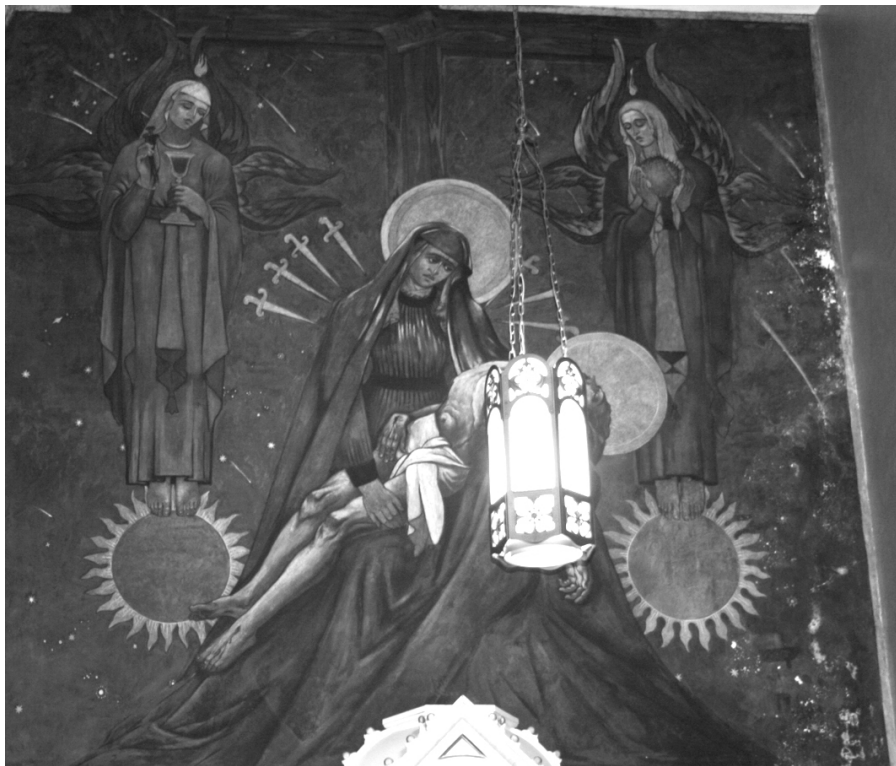
Figure 1. *Pietà* before treatment with efflorescence along right edge.

Water, entering through cracks, migrated through the walls and efflorescence is found primarily in areas of the murals *Pietà* and *Mati 1941*. *Pietà* is located in the corner of the interior of the building to the right of the high altar. Efflorescence is concentrated along the right edge of the mural. *Mati 1941* is located to the right of the large stained glass window, in the adjacent corner. Damage to *Mati 1941* from efflorescence is concentrated along the right edge and is characterized by a dry, fluffy white powder on the surface. Crystallization of infiltrates occurred at the interface of the plaster wall and paint layer. Increased volume of this new formation forced areas of original paint from the surface. Numerous losses resulted from small pockets filled with salts, and, having lost all inherent binding, fell from the wall. The ceiling in the choir loft and the stairwell leading to the north bell tower also exhibit extensive water damage and efflorescence, but these walls do not contain Vanka's paintings.

Contributing to a further weakened condition is the previous conservation treatment carried out in the late 1990s on the *Pietà*, which was to address efflorescence and removal of surface dirt. Water damage from the 2004 hurricanes has appeared in areas of the *Pietà* previously treated. Efflorescence was handled by brushing away the salts and fragile areas were re-adhered with synthetic polymers in the earlier treatment. Fills were made with modern materials and retouching was executed in acrylic. The undamaged, original surface of the *Pietà* was matte while areas with synthetic adhesives appeared dark and saturated, particularly where these polymers had been heavily applied. These materials were chosen, no doubt, in the belief that they were easily reversed. Areas of modern fill were as saturated with salts as original plaster. Passages with modern retouch responded to new water damage by trapping salts beneath the relatively elastic layer and billowing from the surface due to volume of its contents. Earlier attempts to re-adhere weakened areas with polymers failed and delamination of paint from the wall re-occurred.
